Army Lodging Wellness Recommendation

Fort Belvoir - Final Submittal

August 13, 2003

3D/I

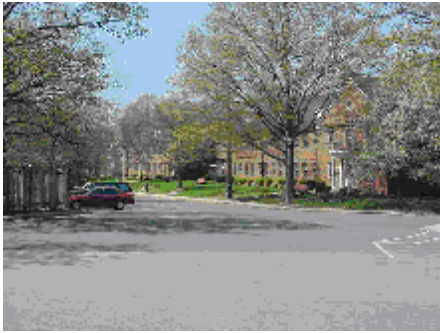
Buildings 80 and 81, constructed in 1948, have been upgraded and renovated in recent years. The two 2-story buildings are mirror images of each other and contain 47 rooms. Building 80 has 44 rooms functioning as standard room, and building 81 has 45 rooms functioning as standard rooms, each with shared baths. Both of these buildings are in poor condition and do not meet current Lodging standards. The cost to make condition assessment improvements will exceed the 50% replacement cost.

Our recommendation is to remove these buildings from the Lodging inventory, allowing the installation to determine an alternate use for the facilities. These facilities will be removed from the Fort Belvoir Wellness Solution and Lodging Master Plan.

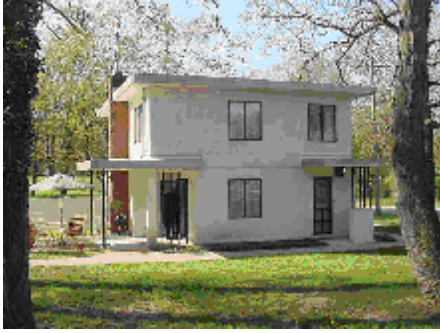
Building 172

Building 172, constructed in the 1950's, received a major renovation in 2000. This building presently has one bedroom and serves as a DVQ. The building is in good condition but does not currently meet the Army Lodging standards. The cost to make improvements and to bring the facility up to Army Lodging standards will exceed the 50% replacement cost.
